FATIGUE BEHAVIOUR OF A ROLLED AZ31 MAGNESIUM ALLOYS PREPARED BY EP AND BB CONDITIONS

Abstract: Rotating bending fatigue tests have been performed using smooth specimens of a rolled AZ31 magnesium alloy in laboratory air at ambient temperature. Fatigue strength and characteristic was evaluated and fracture mechanism was discussed on the basis fracture surface analysis. Electrical polishing (EP) as well as deep rolling (ball burnishing (BB)) U-notched specimens were performed on two groups of samples, to evaluate optimum conditions for fatigue life. The microstructure and tensile properties of roll cast (RC) Mg- 3% Al- 1% Zn (AZ31) was investigated. The fatigue strength of 107 cycles around 100 MPa for deep rolling while it was around 40 MPa for Electrical polishing. It was very important to understand the effect of (ball burnishing (BB)) conditions on the hardness of the surface through to the core. The two procedures improved the fatigue performance, but better improve in results were found in ball burnishing. The growth of small cracks initiated at the surface coincided with the FCP characteristic after allowing for crack closure for large cracks, but the operative fracture mecha

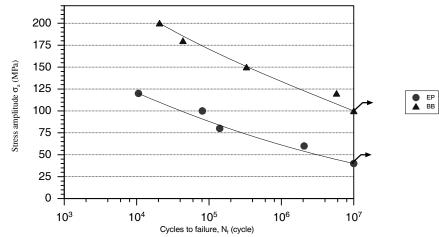
Fig.2. S-N curve for rolled AZ31 at EP,BB conditions, rotating beam, R=-1, 50Hz.

S/N curves for the EP and the BB specimens in laboratory at a stress ratio of -1 and frequency of 50 Hz (rolled magnesium alloy) in laboratory air is shown in Fig. 2. In this figure, for comparison purposes, the S-N curves of the EP and BB specimens are shown respectively. As seen from the figure, the fatigue life of the rolled magnesium alloy of EP specimen is relatively shorter than that of BB specimen. The extent bending in the S-N curve is gentler in the BB specimens than in the EP specimen. Next let us compare the S-N characteristics of the EP and BB specimens. There are great differences in the fatigue lives and in the fatigue limits, especially at higher stress amplitudes, there are differences in the fatigue lives.

The fracture surface of AZ31 for EP condition and BB condition at different stress is shown in Fig. 4. Subsurface crack initiation occurred at applied stresses at 60 MPa. At BB condition but it can be seen for both 80 and 100 MPa stress for EP condition. The S–N diagram is shown in Fig. 2. It is well known that fatigue limit does not exist in non-ferrous alloys, thus fatigue tests were continued until 10⁷ cycles. At EP condition σ = 40 MPa, fatigue failure did not occur, but non-propagating cracks were observed on the specimen surface. As can be seen in the figure, the present Mg alloy seems to possess a definite fatigue limit, which may be related to the existence of non-propagating cracks. The fracture mode depending

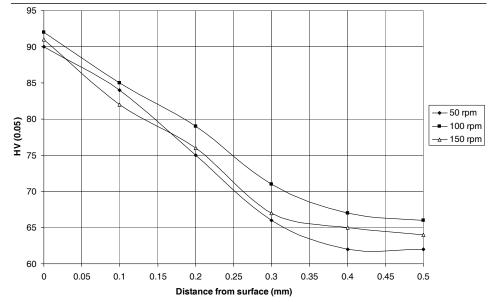
Fig. 3. Microhardness profile oif AZ31 after BB at 200 bars, 0.17 mm/min at different BB rotation speed.

3. 3. A different experiment were used to investigate the best condition for BB (pressure, feed rate, speed) as example for tool HG3 200 bar (123 N) for 50, 100 and 150 rpm. The microhardness measurement from the surface in Fig. 3. Shows that the suitable condition for using 200 bars is 100 rpm for AZ31 as the hardness decreased from the circumference gradually to the center.

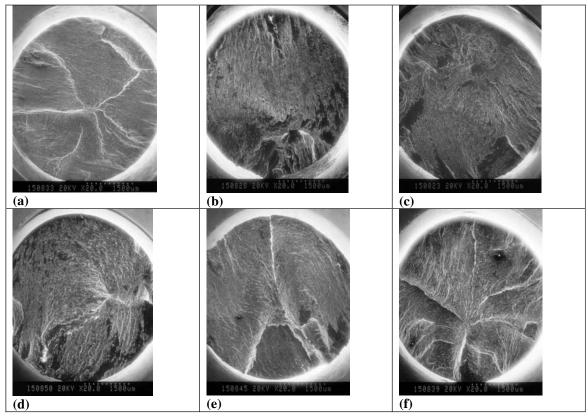
Fig.4. SEM micrographs showing fracture surfaces at difference stress for EP at (a) 60MPa; (b) 80 MPa; (c) 100 MPa and BB at (d) 60MPa; (e) 80 MPa; (f) 100 MPa.

on applied stress level, above 60 MPa cracks initiate at the surface (surface fracture), while below that stress at the interior of the specimen (subsurface fracture). Subsurface fracture is a very interesting finding, which has not been recognized in Mg alloys, for both EP and BB conditions.

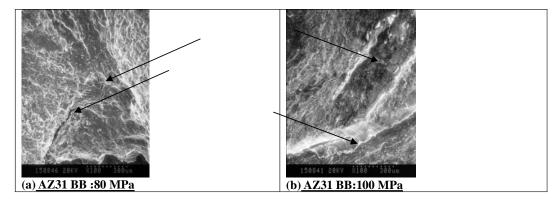
Fig. 5. SEM micrographs showing cracked surfaces at difference stress for BB at (a) 80MPa; (b) 100 MPa

The cracked line could be seen easily for higher stress for BB condition as fracture occurs in internal surface not at the outer surface as in the EP condition in Fig. 5.
